## HOME CHECK IG RESIDENTIAL INSPECTION

6929 Chinook Dr  
Austin, TX 78736

# PROPERTY INSPECTION REPORT FORM

6929 Chinook Dr, Austin, TX 78736

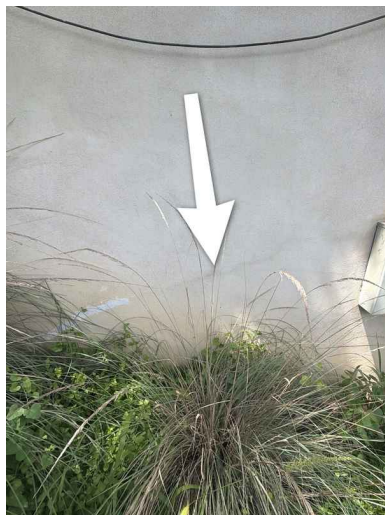
Right Side Of Home

#### **MINOR CRACKS:**

One or more minor cracks were observed in the foundation at the referenced area(s). Cracks are normal as the concrete dries and cures. Cracks that are wider than 1/8 of an inch should be further evaluated. This crack did not meet that criteria. We recommend monitoring over time and should crack widen, we would recommend a professional engineer further evaluate.

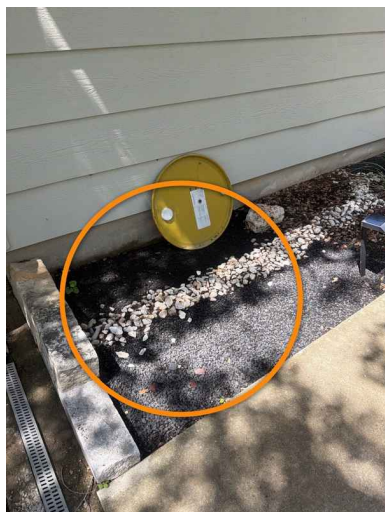
Front Of Home

**1: FLAT/NEGATIVE GRADING**

A flat or negative grade slope towards the foundation was observed in some areas. Proper drainage is needed to help prevent water from standing and/or ponding next to the foundation. Corrective measures may be needed if the water stands within 10 feet of the foundation for more than 24 hours. Any area where the ground or grade does not slope away from the structure is considered an area of improper drainage. We recommend further evaluation to determine if different grading/drainage measures should be taken.

Recommendation: Contact a qualified landscaping contractor

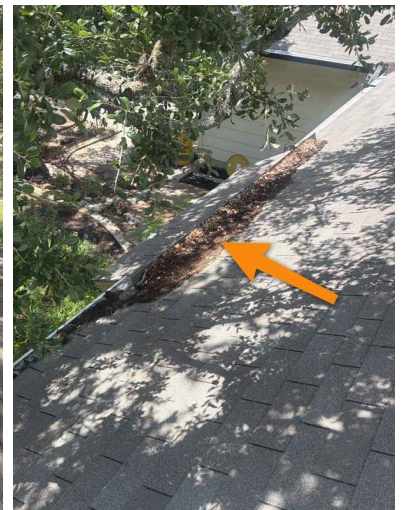
Front Of Home

Debris was observed on the roof surface. This could hold moisture against the roof and diminish life expectancy. We recommend clearing debris off roof surface.

Recommendation: Contact a qualified professional.

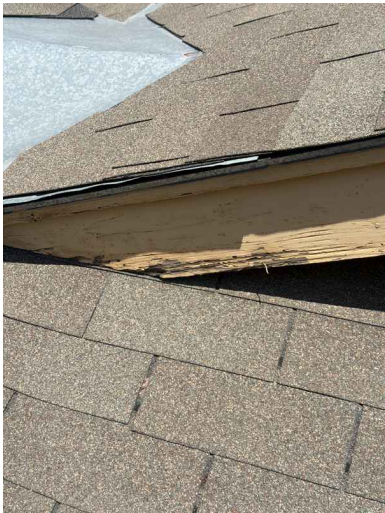
Back Of Home

The fascia board was observed to be deteriorated/damaged in one or more areas. We recommend repair of affected areas to prevent moisture/pest intrusion.

Recommendation: Contact a qualified roofing professional.

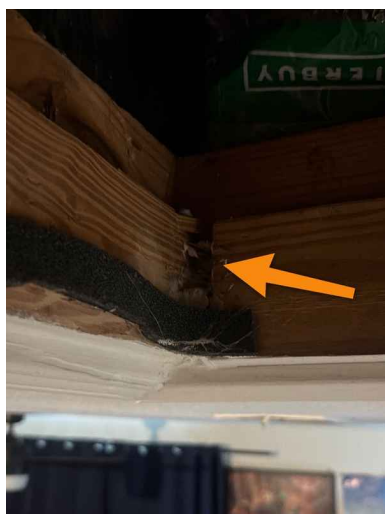
## 6: ATTIC STAIRS – GENERAL DAMAGE

Attic stairs are observed to have general damage or have been altered. Recommend evaluation and repair by a qualified contractor.

Frame Separating

Recommendation: Contact a qualified professional.

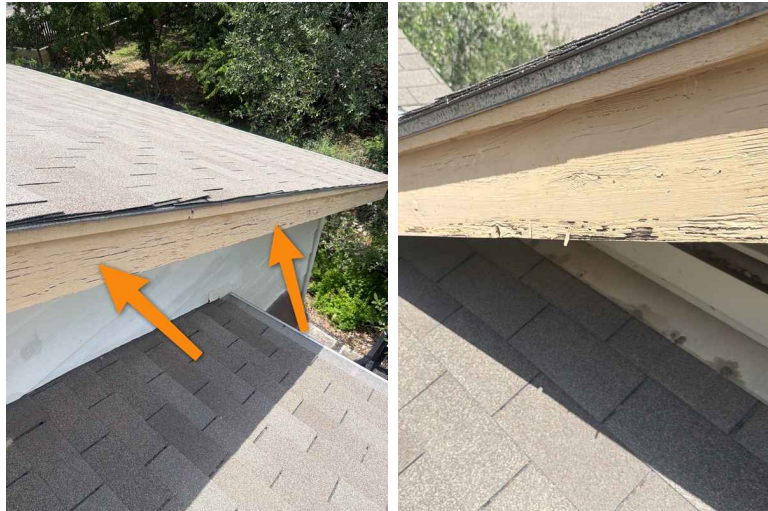
# 1: EXTERIOR PAINT MISSING/PEELING

One or more exterior areas had missing or peeling paint. Surfaces on the exterior should be painted to prevent moisture absorption and/or premature deterioration.

Above roof level on fascia board

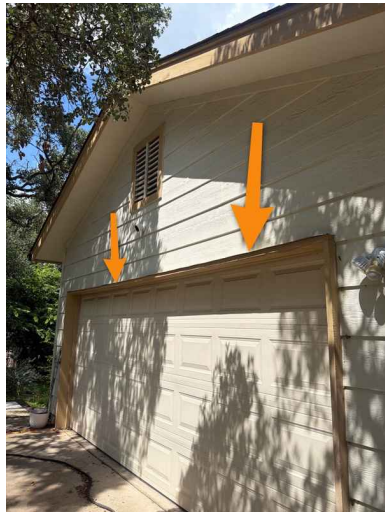
### 3: FLASHING OVER GARAGE IMPROPERLY INSTALLED

Recommendation: Contact a qualified siding specialist.

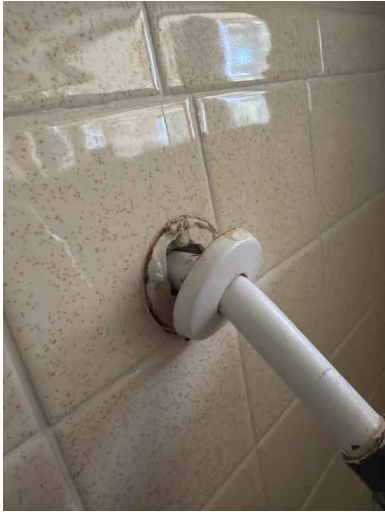
Hallway Bathroom

**9: TUB/SHOWER GROUT/CAULK REPAIR NEEDED**

Areas of the caulking/grout in the tub/shower(s) are missing/deteriorated or in need of repair. In order to prevent water intrusion, I recommend having this evaluated and repaired as necessary by a qualified tile contractor.

Recommendation: Contact a qualified tile contractor

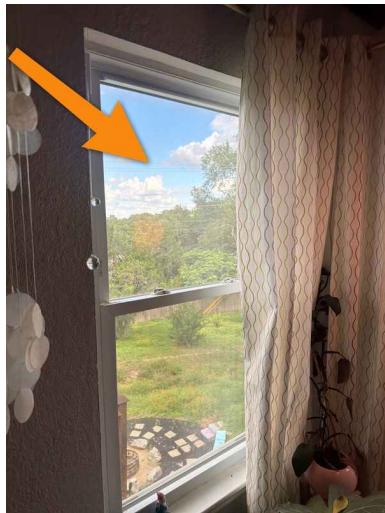
### 1: BALANCE REPAIR RECOMMENDED

The referenced window(s) had balance deficiencies present. Balances are the mechanisms that allow the window sash to open and close with ease, as well as keeping windows in the open position without falling. We recommend a window professional repair, clean, lubricate, or adjust as necessary.

Upper sash balance damaged

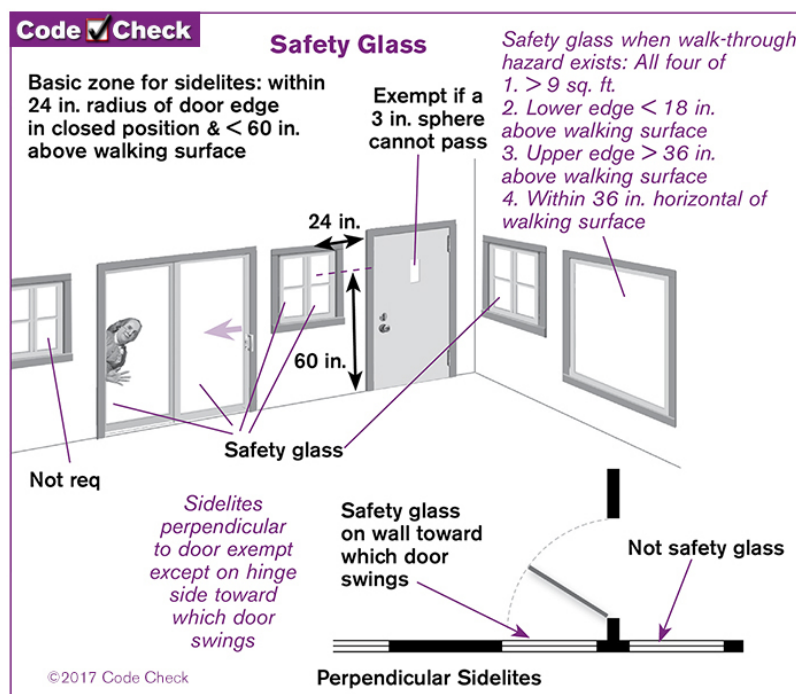
**2: SAFETY GLASS REQUIREMENT NOT MET****▲ Safety Hazard/Significant Defect**

Safety glass (Tempered) was not observed in a required location. This is a safety issue and should be corrected by a qualified person. Photo below shows areas where safety glass is required.

Recommendation: Contact a qualified window repair/installation contractor.

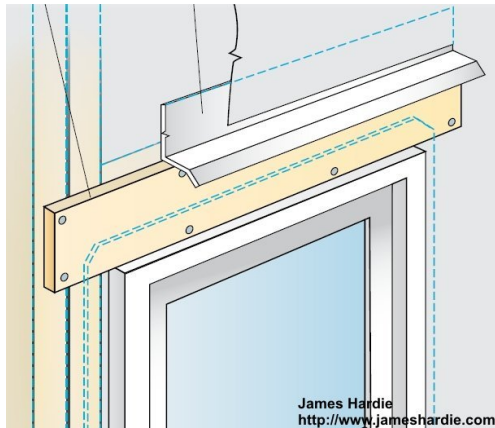
There are no separate metal drip cap flashings over the windows or any associated horizontal window trim. Often no problem is created by the lack of flashings, depending on any integral flashings that are built into the windows and how well the horizontal surface is installed and sealed (caulked). We recommend to inspect and install.

Recommendation: Contact your builder.

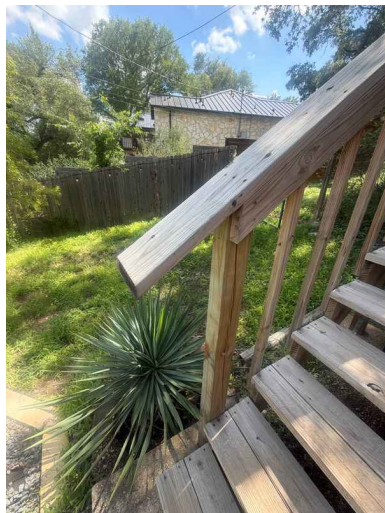
## 2: HANDRAILS-IMPROPER TERMINATION

Handrails are required to terminate in a newel post or return to the wall. The interior stairs did not return to the wall.

Recommendation: Contact a qualified professional.

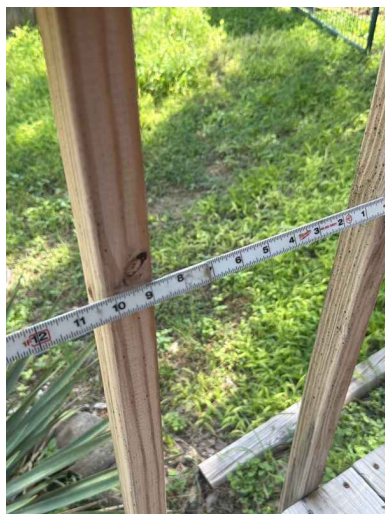
The guard rails on the stairs had spacing present that would allow the passage of a 4 inch sphere. Current safety standards require that guardrails be designed as to not allow the passage of a 4 inch sphere through them. Safety upgrades or modifications are recommended to be conducted here by a qualified person.

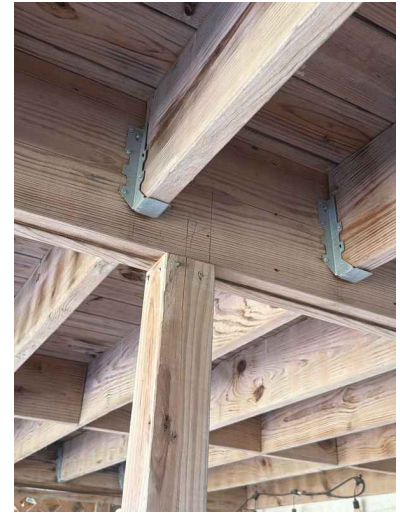
#### Post to Beam Connection

## 3: POST-BEAM CONNECTION LACKING BOLTS

The deck beam was properly resting on the support posts however the connection was not properly bolted together. We recommend through bolts be added by a qualified professional to properly attach beams to post as per DCA-6 deck construction guidelines.

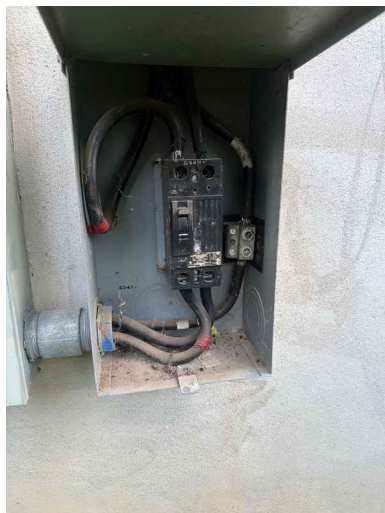
Main Electrical Panel

**3: GROUNDING NOT OBSERVED****▲Safety Hazard/Significant Defect**

Recommendation: Contact a qualified electrical contractor.

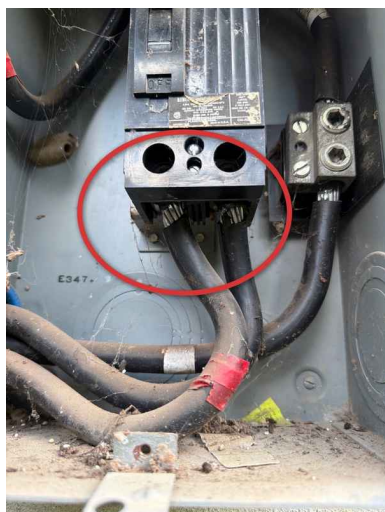
Main Electrical Panel

#### 4: LOAD TERMINATION BARRIERS NOT PRESENT

Recommendation: Contact a qualified electrical contractor.

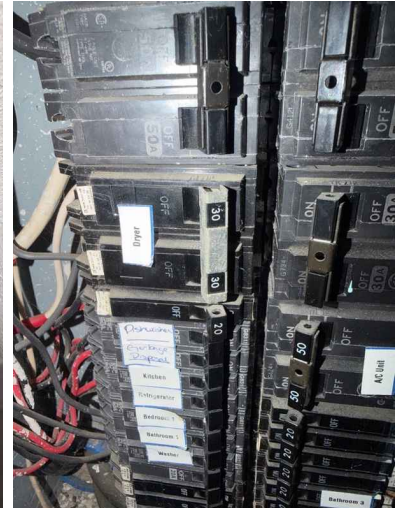
Laundry Room

Dryer branch circuit not GFCI protected

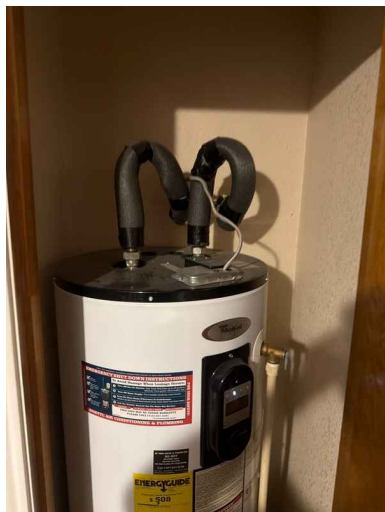
No service disconnect at water heater

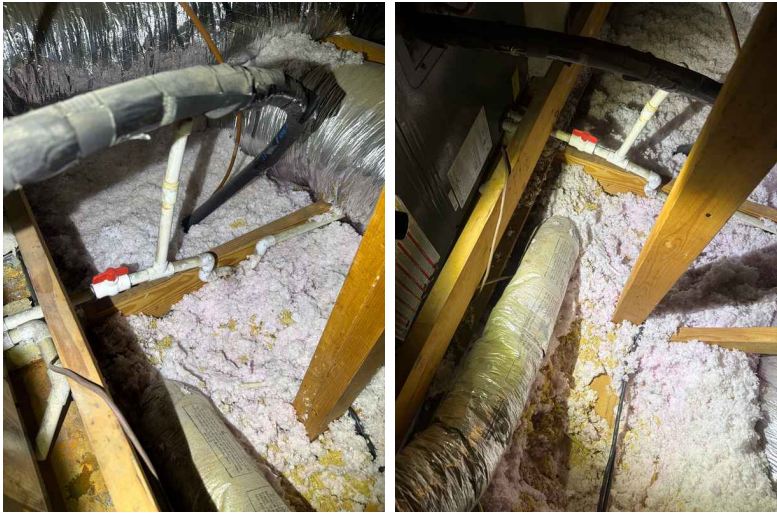
## 3: INADEQUATE CLEARANCE IN FRONT OF UNIT

Appliances should have a 30 inch by 30 inch clearance in front of the appliance for servicing and inspection. This was not present in front of this unit.

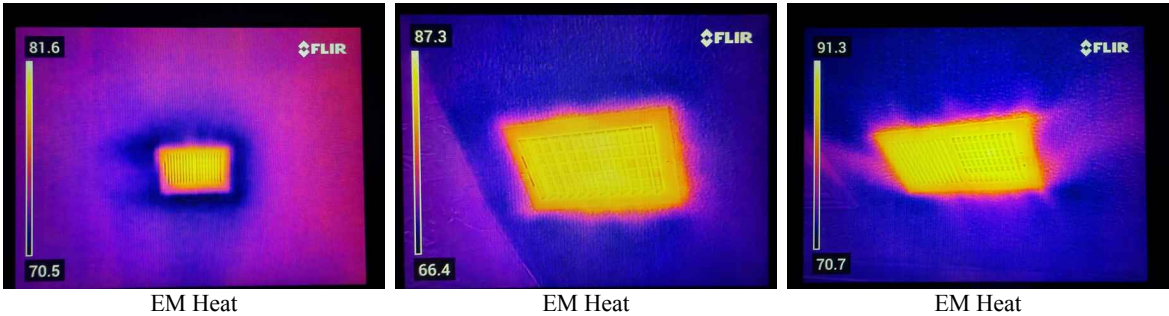
4: INSUFFICIENT HEAT - AUX/EM HEAT MODE

The air temperature at supply registers for heat pumps in auxiliary heat or emergency heat mode typically ranges between 105° to 120° F in this mode. This temperature was not achieved when the Em Heat was run at today’s inspection. We recommend further evaluation by a licensed HVAC technician.

Recommendation: Contact a qualified HVAC professional.

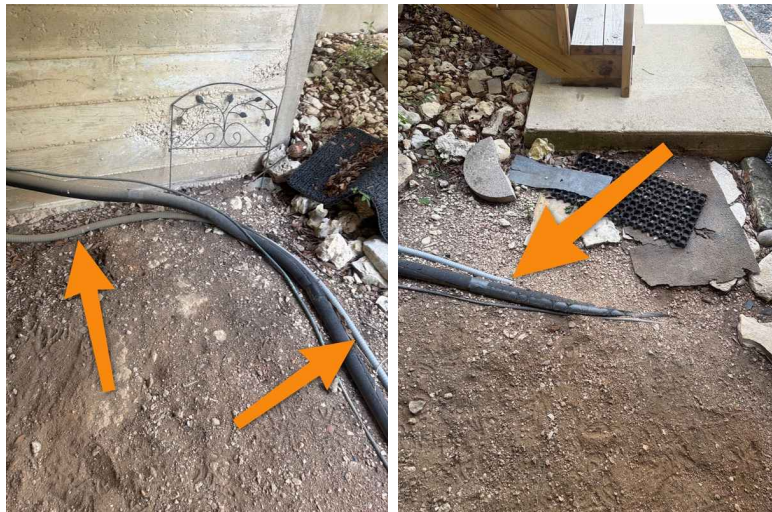
#### 4: ELECTRICAL FEEDWIRE ATTACHMENT LOOSE

The securement piece was loose at the wall. Recommend reattachment.

Recommendation: Contact a qualified professional.

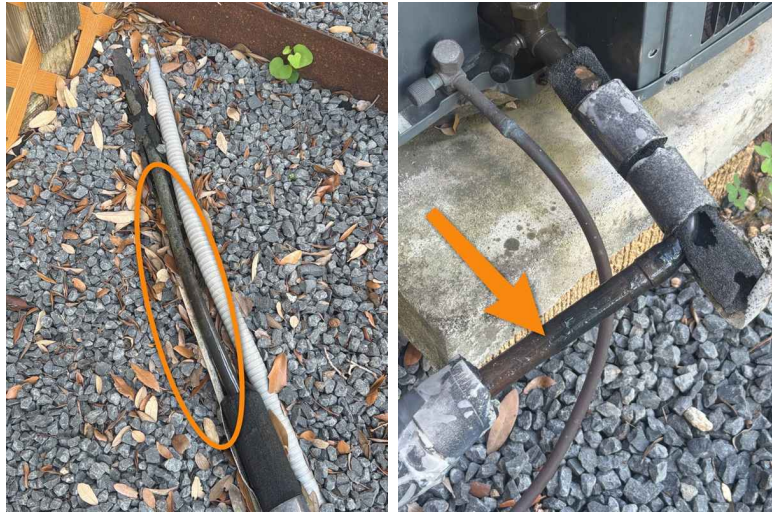
#### 5: INSULATION MISSING/DAMAGED

Missing/damaged insulation was observed on the refrigerant line. Missing/damaged insulation on refrigerant line can cause energy loss and condensation. Recommend adding insulation to areas where it's missing.

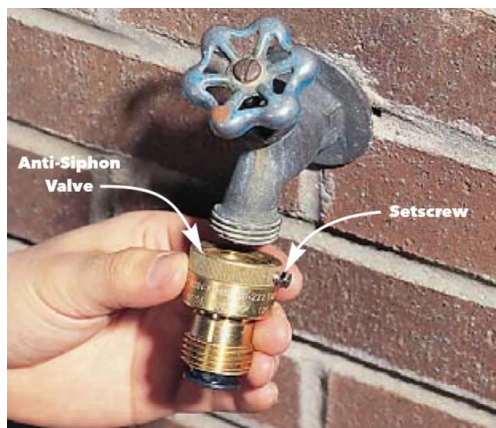
One or more exterior hose bibs was not equipped with anti siphon device. These are designed to help prevent back siphon-age should something happen on the city side that causes a pressure drop. Recommend adding anti-siphon device by a licensed plumbing professional.

Recommendation: Contact a qualified plumbing contractor.
