## HOME CHECK IG RESIDENTIAL INSPECTION

6929 Chinook Dr  
Austin, TX 78736

# PROPERTY INSPECTION REPORT FORM

6929 Chinook Dr, Austin, TX 78736

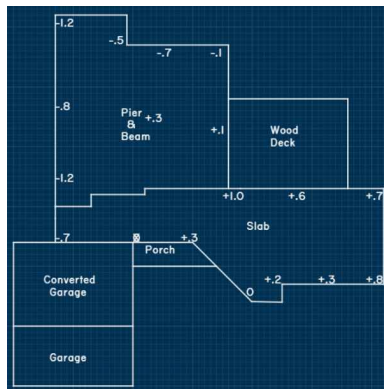
Foundation elevation measurements were taken on the first floor using a Zip Level™. The measurements are reported in the diagram below. Due to differences in floor coverings, and workmanship, measurements do not necessarily represent the actual degree of deflection of the foundation. When coupled with other indicators, these measurements can assist the inspector in formulating an opinion of foundation performance, but in and of themselves should not be considered an absolute indicator of foundation movement.

Foundation elevation measurements were gathered using a Zip Level. The variance from the highest point to the lowest point was 2 inches or greater indicating that the slab is out of level to some degree. Slabs have an allowable tolerance for deflection and tilt that are percentage based. This comes from the size of the foundation and the degree of variance. It is possible that this variance is within tolerances and that even a larger variance is acceptable for this home however calculating this is beyond the limited scope of a general home inspection.

Recommendation: Contact a qualified structural engineer.

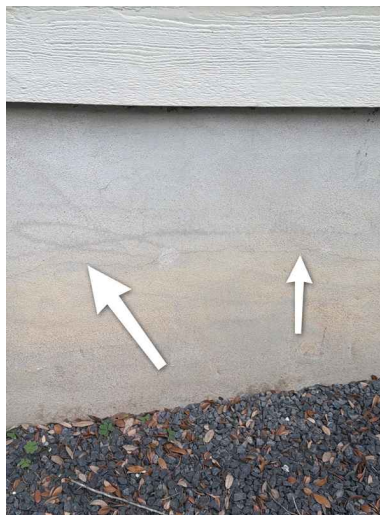
Left Side Of Home

One or more minor cracks were observed in the foundation at the referenced area(s). Cracks are normal as the concrete dries and cures. Cracks that are wider than 1/8 of an inch should be further evaluated. This crack did not meet that criteria. We recommend monitoring over time and should crack widen, we would recommend a professional engineer further evaluate.

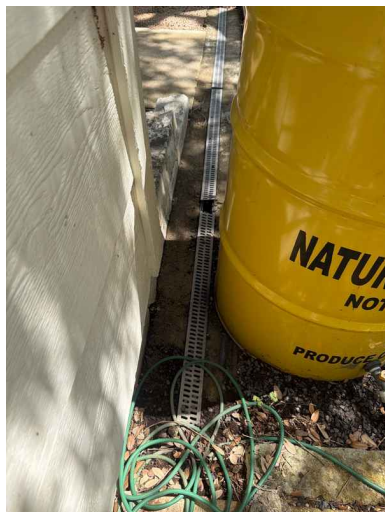
**1: FLAT/NEGATIVE GRADING**

A flat or negative grade slope towards the foundation was observed in some areas. Proper drainage is needed to help prevent water from standing and/or ponding next to the foundation. Corrective measures may be needed if the water stands within 10 feet of the foundation for more than 24 hours. Any area where the ground or grade does not slope away from the structure is considered an area of improper drainage. We recommend further evaluation to determine if different grading/drainage measures should be taken.

Recommendation: Contact a qualified landscaping contractor

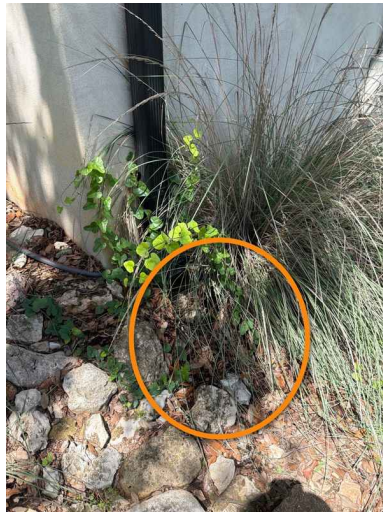
Front Right Corner Of Home

### 3: TREES WITHIN 10 FEET OF HOME

There were trees within 10 feet of the home. It is recommended that trees be no closer than 10 feet from the home as they can cause a multitude of issues from foundation, to siding, to roof problems. If concerns exist about the foundation, a root barrier can be installed as a solution. We recommend contacting a foundation company if any of these concerns exist before making any changes.

Recommendation: Contact a qualified professional.

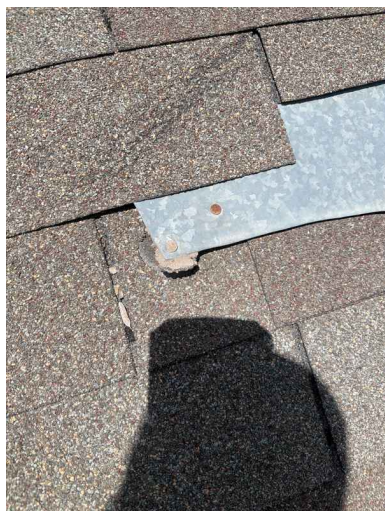
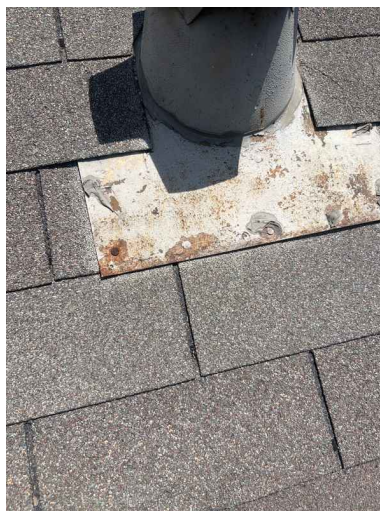
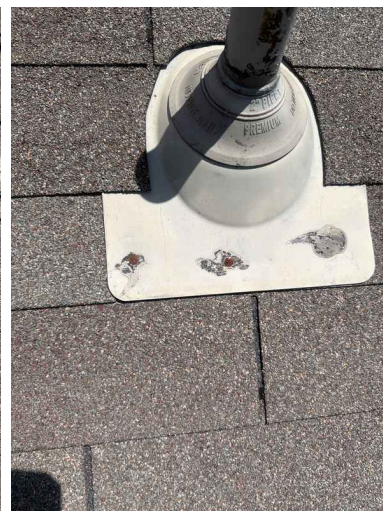
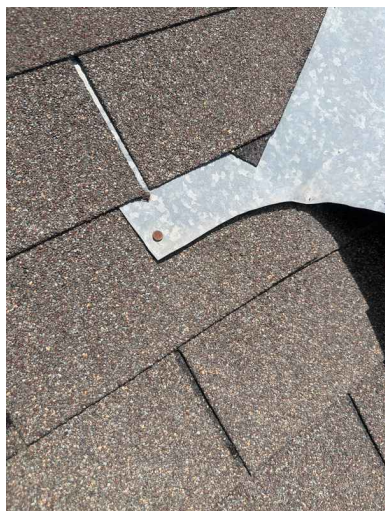
There are exposed fasteners on the roof. Sealant should be applied to exposed fastener heads to prevent moisture from penetrating the roof in those areas. Photos are not all inclusive and it is recommended that a roofer further inspect and address all areas where sealant may be needed.

Recommendation: Contact a qualified roofing professional.

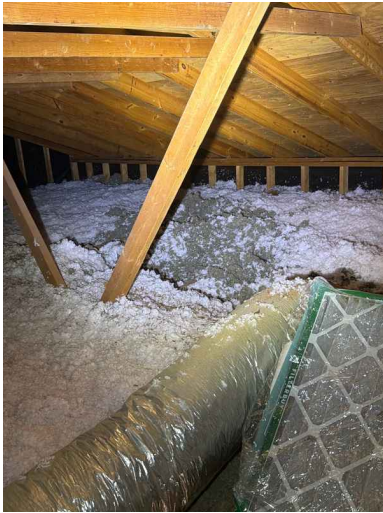
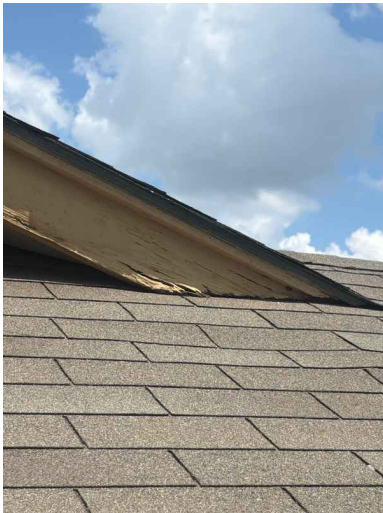
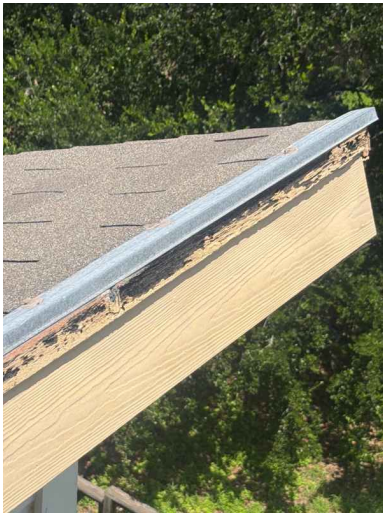
Back Of Home

**3: FASCIA BOARD DETERIORATION**

The fascia board was observed to be deteriorated/damaged in one or more areas. We recommend repair of affected areas to prevent moisture/pest intrusion.

Recommendation: Contact a qualified roofing professional.

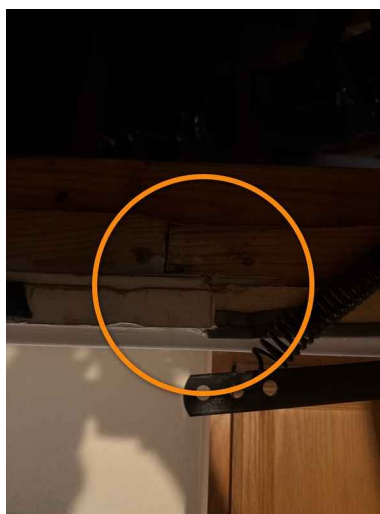
Attic stairs are observed to have general damage or have been altered. Recommend evaluation and repair by a qualified contractor.

Frame appears to have been cut and altered

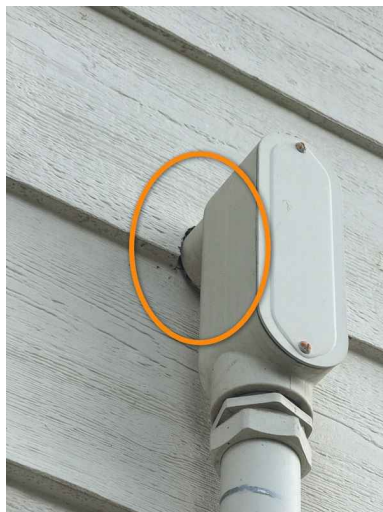
Right Side Of Home

Exterior caulk/sealant improvements are recommended. Trim around the house, at transitions, windows, siding/expansion joints, wall penetrations and similar areas should be adequately caulked/sealed to prevent water intrusion in those areas.

Recommendation: Contact a handyman or DIY project

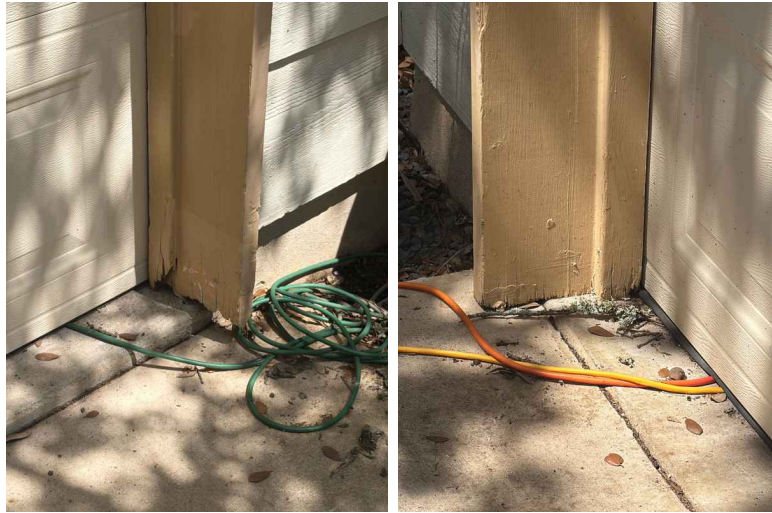
The bottom of the garage trim should be cut back so that it is not in constant contact with the ground. This could cause it to hold moisture and deteriorate more quickly. We recommend cutting it up some to prevent premature deterioration.

Recommendation: Contact a qualified carpenter.

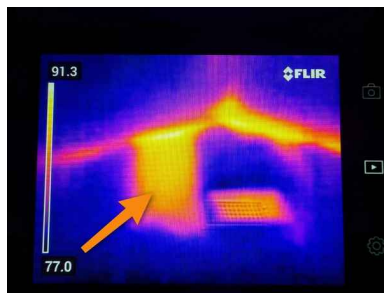
Primary Bedroom

### 5: POSSIBLE WALL INSULATION MISSING

What appeared to be missing wall insulation was observed in one or more areas. We recommend further evaluation to ensure wall cavity has been properly insulated.

Recommendation: Contact a qualified insulation contractor.

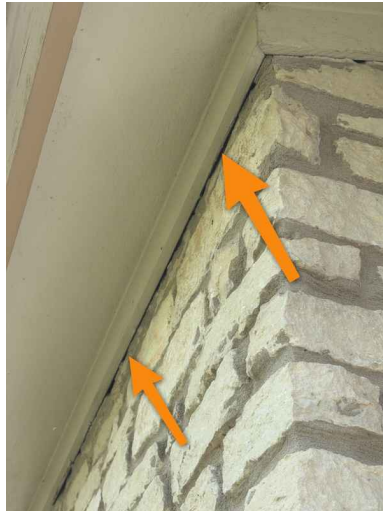
Front Of Home

### 6: OPENINGS NOT SEALED

There are one or more exterior wall openings/holes that are not sealed. These openings/holes should be sealed to help prevent moisture and/or pest intrusion in those areas.

Recommendation: Contact a qualified professional.

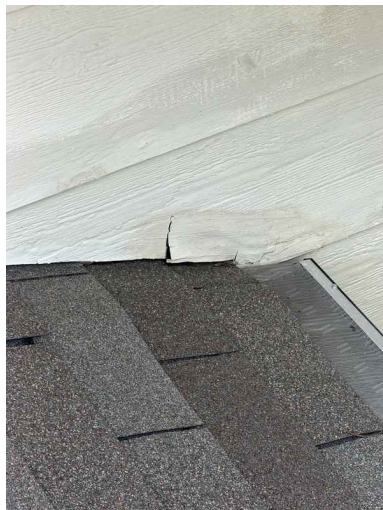
Roof level

**7: SIDING DETERIORATION**

Siding was observed to be deteriorated in areas. Recommend replacement of affected areas.

Recommendation: Contact a qualified siding specialist.

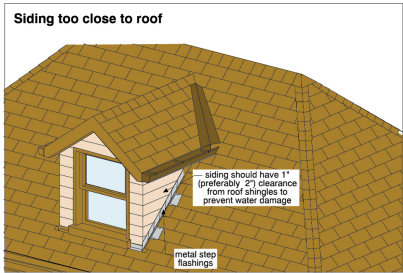
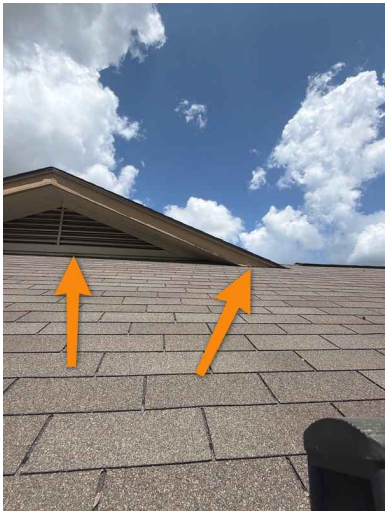
**8: SIDING TOUCHING ROOF**

Siding was observed to be in contact with the roof surface. There should be 1-2 inches of separation between the siding and the roof surface. Any trim that is in contact with the roof's surface could potentially allow moisture to wick into it and cause premature deterioration.

Recommendation: Contact a qualified siding specialist.

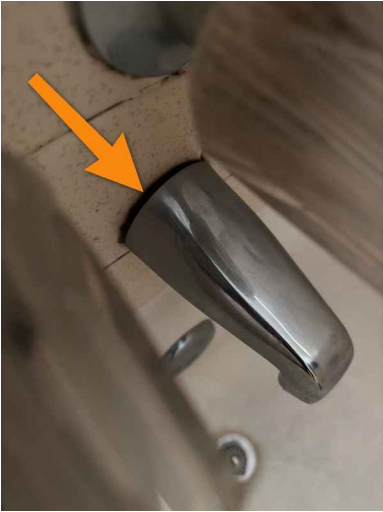
Hallway Bathroom

**9: TUB/SHOWER GROUT/CAULK REPAIR NEEDED**

Areas of the caulking/grout in the tub/shower(s) are missing/deteriorated or in need of repair. In order to prevent water intrusion, I recommend having this evaluated and repaired as necessary by a qualified tile contractor.

Recommendation: Contact a qualified tile contractor

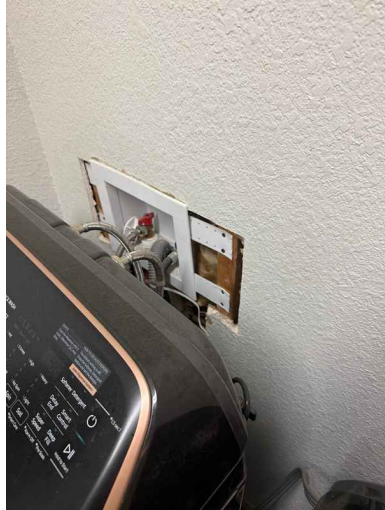
Laundry Room

The appeared to be areas of unfinished work throughout the home. We recommend repair/completion of work.

Recommendation: Contact a qualified professional.

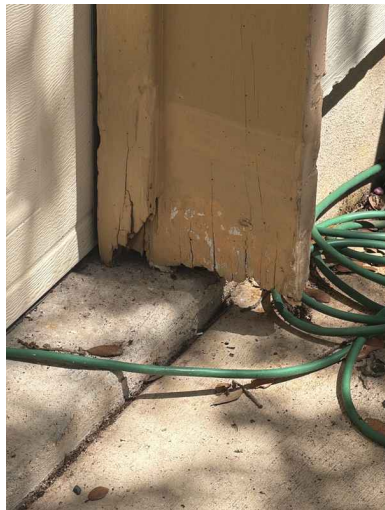
Front Of Home

**11: WOOD DETERIORATION-EXTERIOR**

Wood deterioration was observed in one or more areas. Recommend repair/replacement by a qualified contractor.

Recommendation: Contact a qualified siding specialist.

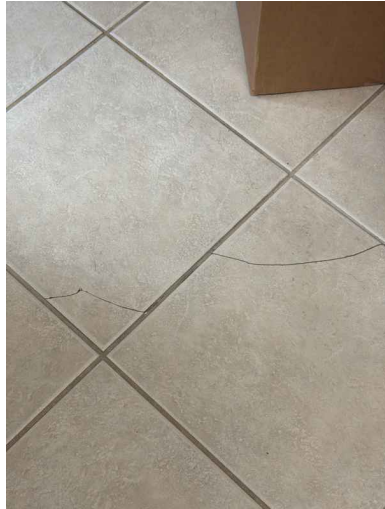
Kitchen

## 1: FLOOR - CRACKED TILE

One or more cracks was observed in the tile. Recommend repair or replacement.

Recommendation: Contact a qualified flooring contractor

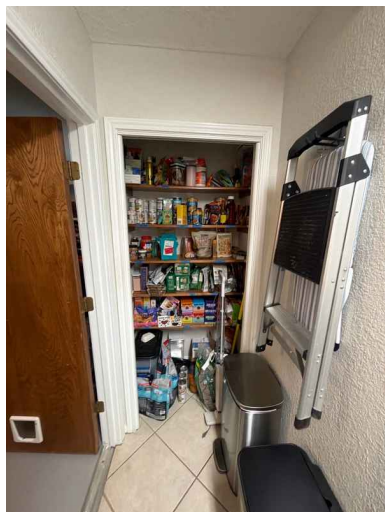
Pantry

There were no installed doors in the referenced areas(s). We recommend installing doors as needed.

Recommendation: Contact a qualified door repair/installation contractor.

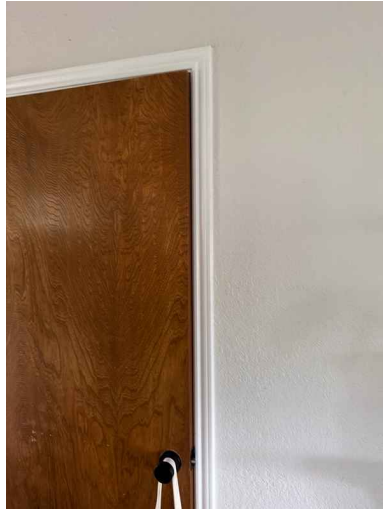
Front entry closet

## 2: RUBS FRAME

Door rubs the frame. This could indicate settlement in that area. Recommend repair.

Recommendation: Recommended DIY Project

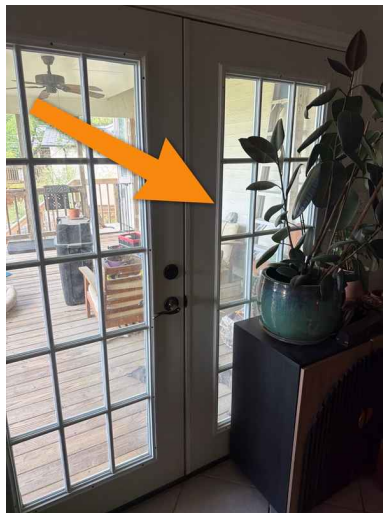
### 3: DOOR DID NOT OPEN

The right side double door at the living room did not open. Recommend further investigation.

Recommendation: Contact a qualified professional.

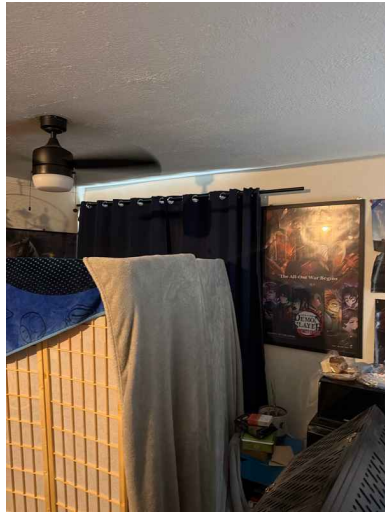
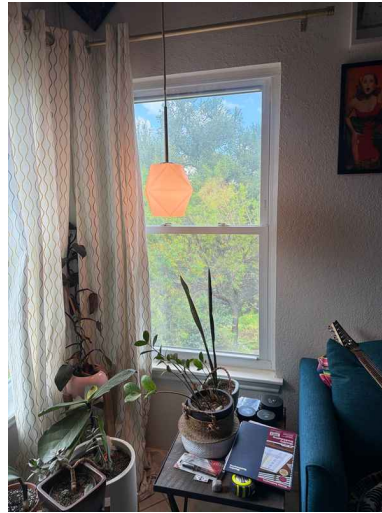
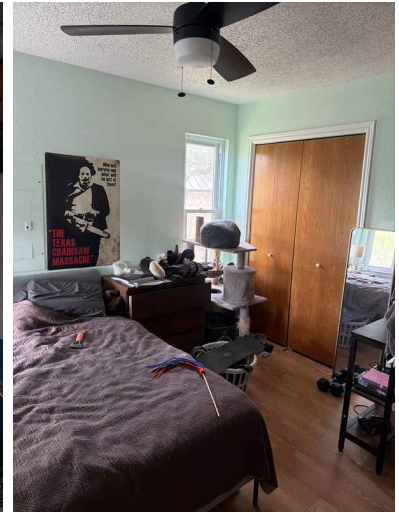
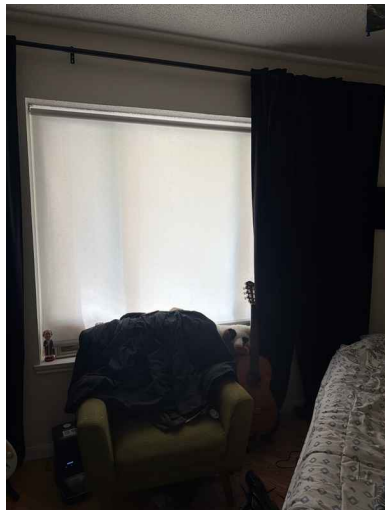
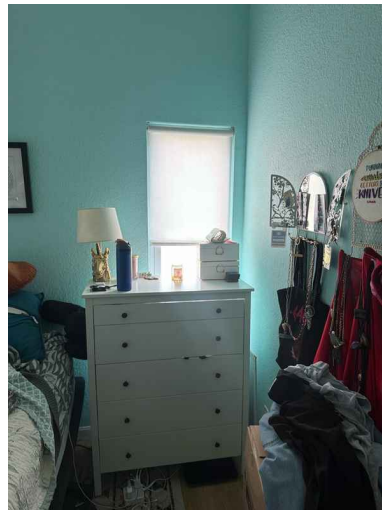
### 1: BALANCE REPAIR RECOMMENDED

The referenced window(s) had balance deficiencies present. Balances are the mechanisms that allow the window sash to open and close with ease, as well as keeping windows in the open position without falling. We recommend a window professional repair, clean, lubricate, or adjust as necessary.

Recommendation: Contact a qualified window repair/installation contractor.

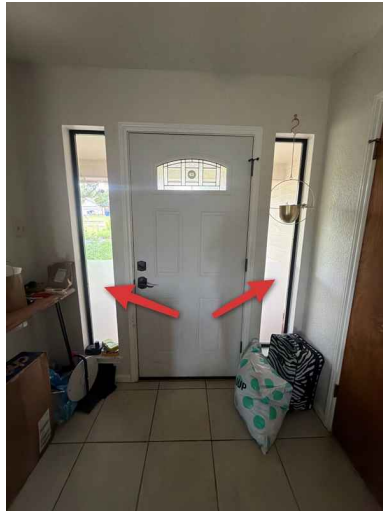
Front entry door

**2: SAFETY GLASS REQUIREMENT NOT MET****▲ Safety Hazard/Significant Defect**

Safety glass (Tempered) was not observed in a required location. This is a safety issue and should be corrected by a qualified person. Photo below shows areas where safety glass is required.

Recommendation: Contact a qualified window repair/installation contractor.

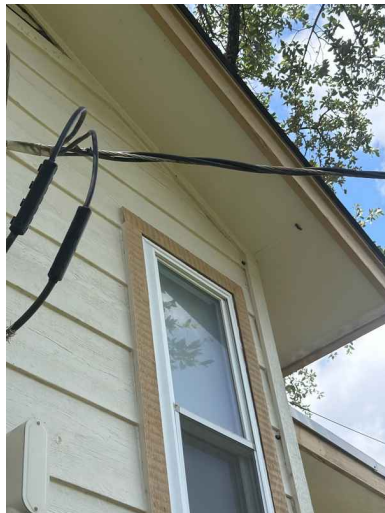
Right Side Of Home

### 3: Z-FLASHING LACKING

There are no separate metal drip cap flashings over the windows or any associated horizontal window trim. Often no problem is created by the lack of flashings, depending on any integral flashings that are built into the windows and how well the horizontal surface is installed and sealed (caulked). We recommend to inspect and install.

Recommendation: Contact your builder.

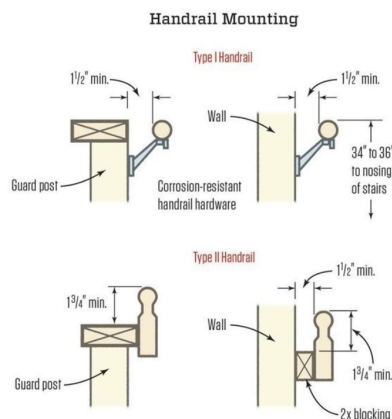
**1: HANDRAIL NOT GRASPABLE**

The handrail was not "graspable" by today's standards. Handrails are recommended to meet certain sizes, shapes, and clearances from walls, so they can be adequately grasped for safety while traversing the stairway. Upgrades are recommended to be performed to the handrail as needed for safety by a qualified person.

Recommendation: Contact a qualified professional.

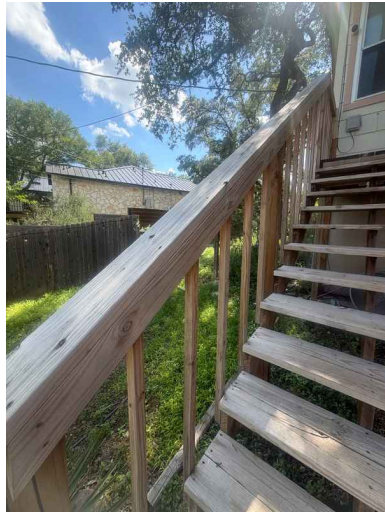
## 2: HANDRAILS-IMPROPER TERMINATION

Handrails are required to terminate in a newel post or return to the wall. The interior stairs did not return to the wall.

Recommendation: Contact a qualified professional.

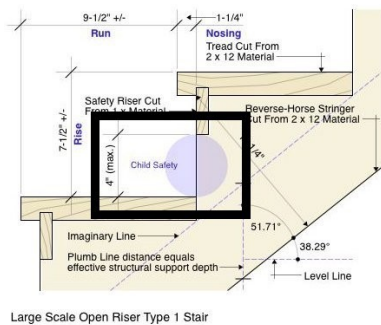
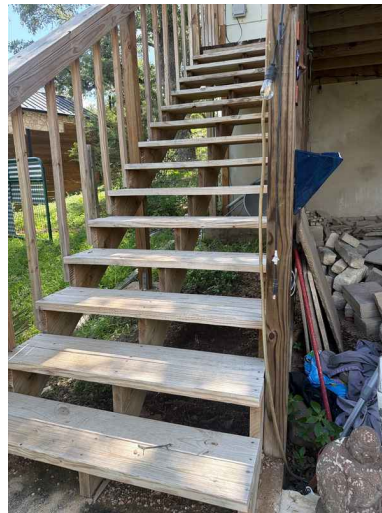
#### 4: STAIRS GUARDRAIL OPENING GREATER THAN 4"

The guard rails on the stairs had spacing present that would allow the passage of a 4 inch sphere. Current safety standards require that guardrails be designed as to not allow the passage of a 4 inch sphere through them. Safety upgrades or modifications are recommended to be conducted here by a qualified person.

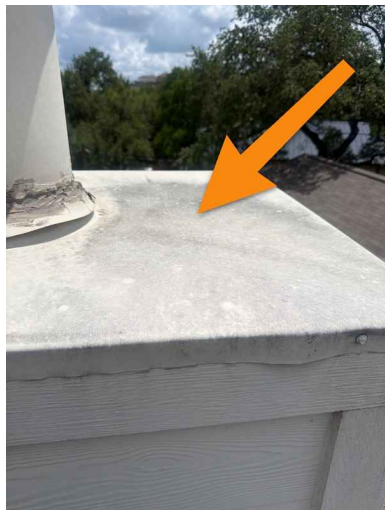
The chimney cap should slope away to shed water away and off the sides of the chimney. The current configuration could allow water to sit on the chimney cap and cause rust, eventually deteriorating the cap. Water intrusion can result. Recommend repair or replacement.

Stains from water pond

Recommendation: Contact a qualified chimney contractor.

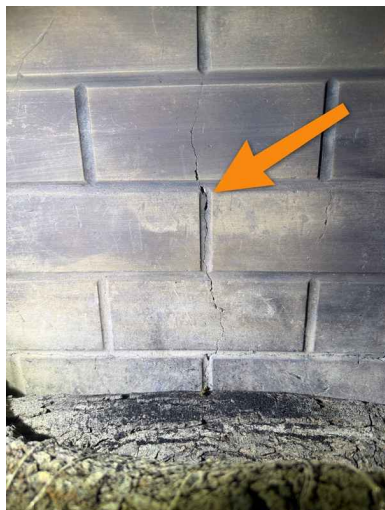
## 2: FIREBOX CRACK(S) OBSERVED

The brick lining of the fireplace was cracked in one or more places, which could lead to chimney damage, overheating of chimney components, and/or toxic fumes entering the home. Recommend a qualified fireplace contractor evaluate and repair prior to first use.

Recommendation: Contact a qualified fireplace contractor.

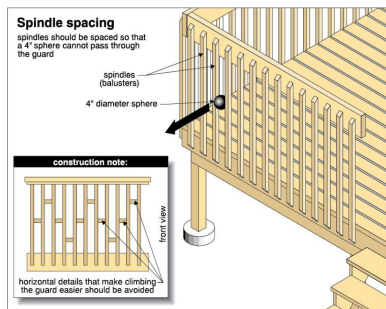
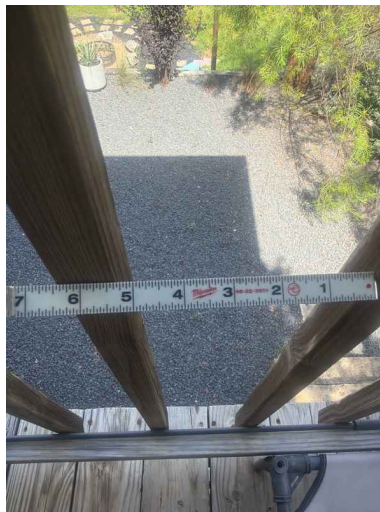
The guard rails had spacing present that would allow the passage of a 4 inch sphere. Current safety standards require that guardrails be designed as to not allow the passage of a 4 inch sphere through them. Safety upgrades or modifications are recommended to be conducted here by a qualified person.

Recommendation: Contact a qualified deck contractor.

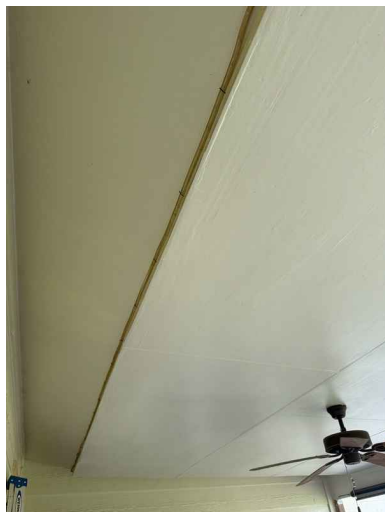
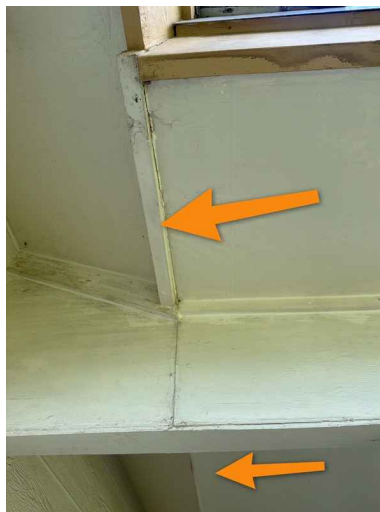
## 2: PATIO COVER ATTACHED TO FASCIA

The patio cover was observed to be attached to the fascia board. It is unknown if the fascia board was properly attached to the rafters to provide it with structural strength to support the weight of the patio cover. We recommend further evaluation.

Recommendation: Contact a qualified structural engineer.

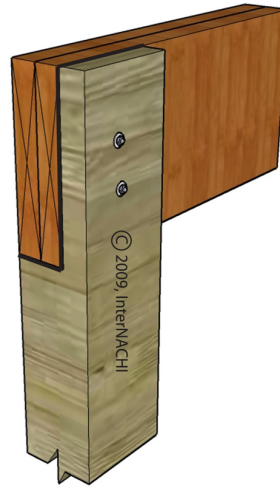
#### Post to Beam Connection

## 3: POST-BEAM CONNECTION LACKING BOLTS

The deck beam was properly resting on the support posts however the connection was not properly bolted together. We recommend through bolts be added by a qualified professional to properly attach beams to post as per DCA-6 deck construction guidelines.

Recommendation: Contact a qualified deck contractor.

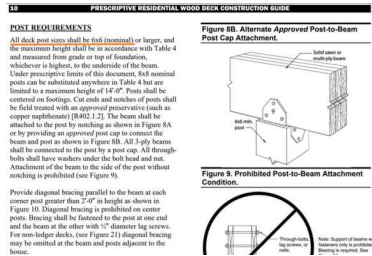
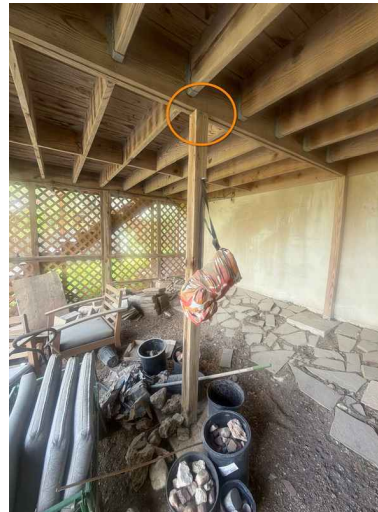
### 4: POST-UNDERSIZED

Posts were observed to be undersized at areas of the deck. All deck posts should be 6"x6" or larger in order to properly support the deck. We recommend having the deck evaluated and addressed by a qualified deck contractor.

4x4 post

Recommendation: Contact a qualified deck contractor.

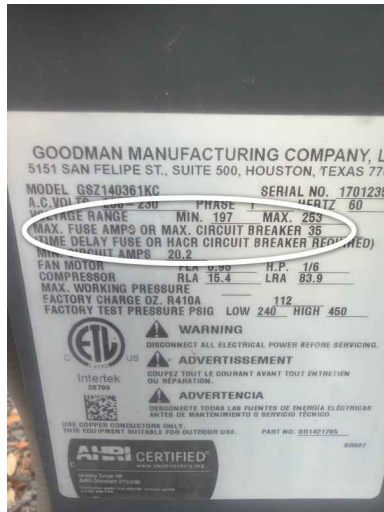
Manufacturer Max allowed 35 amp circuit breaker

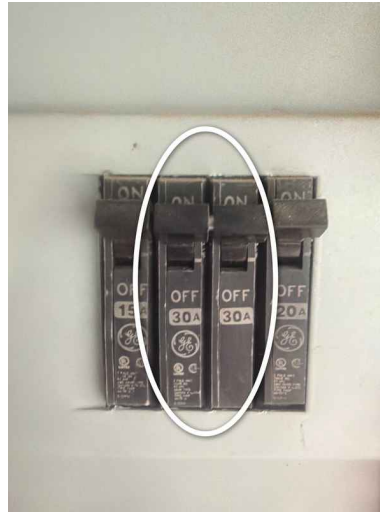
30 amp circuit breaker installed

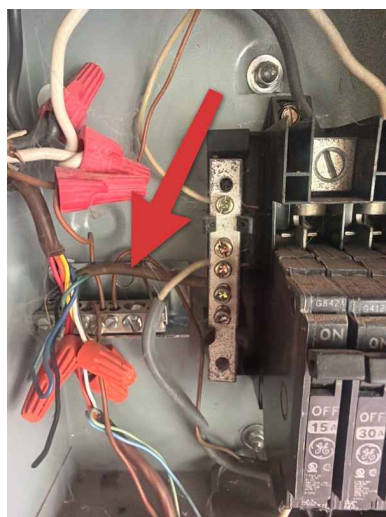
Exterior Sub Panel

**2: GROUNDS AND NEUTRALS NOT SEPARATED IN SUB PANEL****▲Safety Hazard/Significant Defect**

Sub-Panel grounds and neutrals were not properly separated. The ground wires and neutral wires should be separated at sub-panels with neutrals on their own separate bus bar, and grounds on a bar connected to the cabinet to bond it. When neutrals and grounds are connected together at subpanels, current will have alternate paths of travel and could run through the ground wires, panels, piping or other bonded components and could pose shock hazards. Although the sub-panel may be functional, it does not meet current National Electric Code standards and should be further evaluated by a licensed electrician.

Recommendation: Contact a qualified electrical contractor.

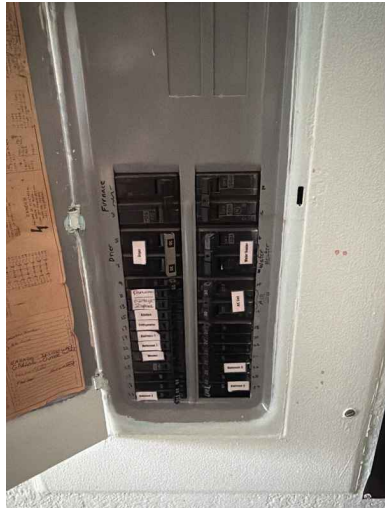
Interior Sub Panel

The legend for the electrical panel was missing, incomplete, or incorrect. A proper legend is required so that breakers are properly labeled, ensuring correct circuits are shut off in case of the need of service, etc. Properly labeling the breakers is recommended to be conducted by a licensed electrician.

Recommendation: Contact a qualified electrical contractor.

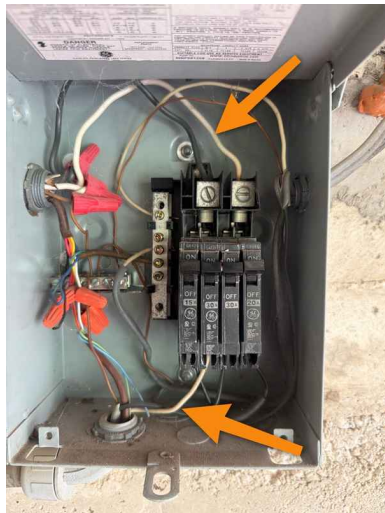
Exterior Sub Panel

**6: WIRES NOT PROPERLY IDENTIFIED**

Wires were observed to missing correct identification.

We recommend a licensed electrician properly identify wires where incorrect.

Recommendation: Contact a qualified electrical contractor.

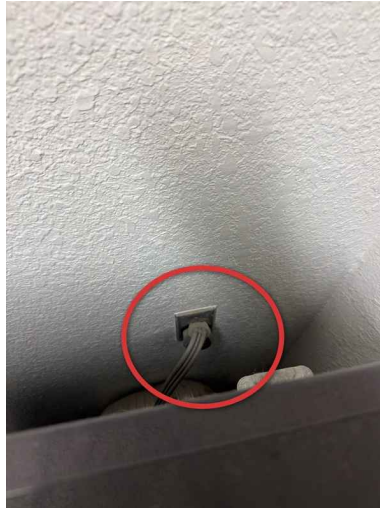
Laundry Room

## 1: GFCI NOT OBSERVED WHERE CURRENTLY REQUIRED

GFCI protection was not observed as required by current building standards in one or more required locations. GFCI protection is currently required on all receptacles in bathrooms, laundry rooms, kitchens, garages, outdoors, within 6' of a sink, tub, shower, and in attics with HVAC equipment installed. This includes 240/250V receptacles. One or more of these may not have been required when this home was built. Although bringing a home up to current building standards is not required, the Texas Real Estate Commission requires home inspectors to communicate any GFCI deficiencies to buyers and we recommend improving when possible for increased safety.

Recommendation: Contact a qualified electrical contractor.

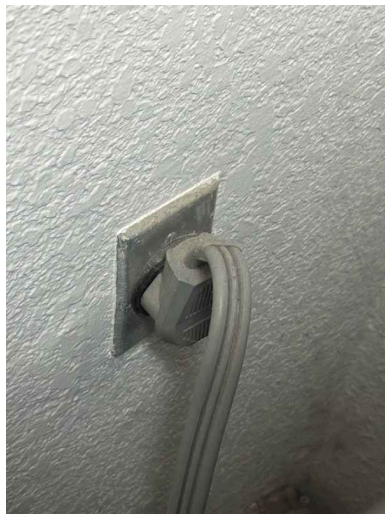
A 3 prong dryer outlet was observed in this home. In 1996, the National Electric Code changed to require new homes to have 4-prong outlets for electric clothes dryers. This helped remove the potential for electrical shock.

Recommendation: Contact a qualified electrical contractor.

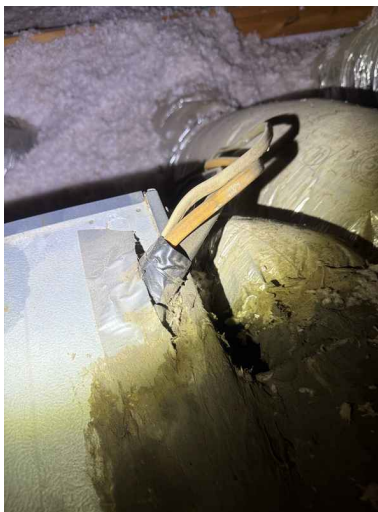
No service disconnect at furnace

Recommendation: Contact a qualified electrical contractor.

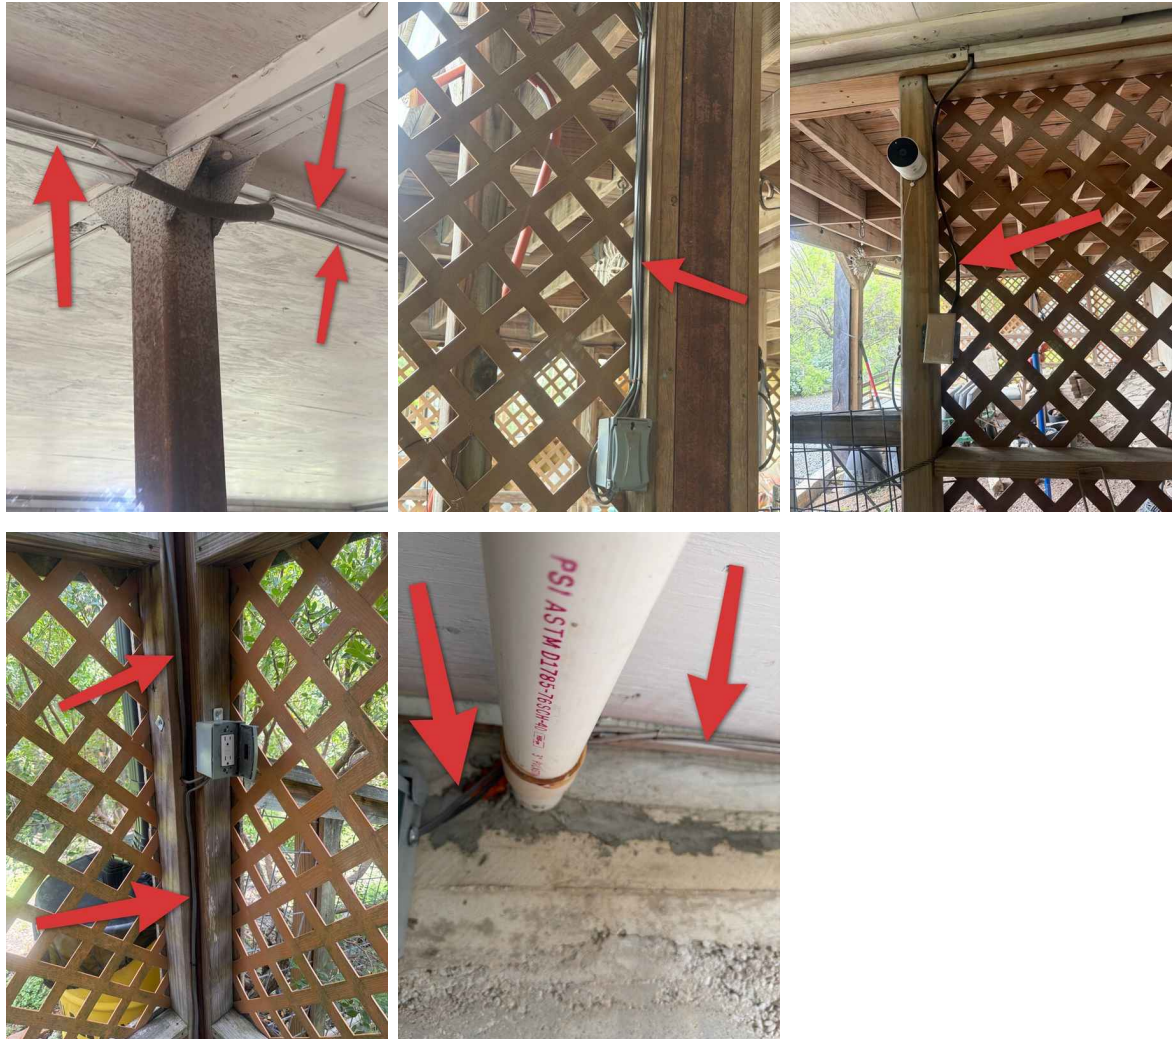
Back Of Home

**6: EXPOSED WIRING****▲Safety Hazard/Significant Defect**

Exposed wiring was present at the home that was not in conduit, and is therefore subject to physical damage. The only areas that wiring can be exposed are in attics or in wall cavities. It must be protected where it passes through the wall or when installed outside. The installation of conduit to protect this wiring is recommended by a licensed electrician.

Recommendation: Contact a qualified electrical contractor.

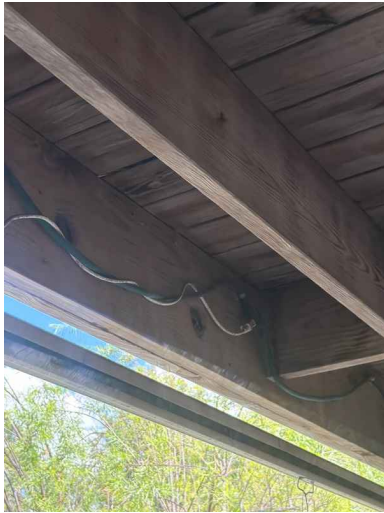
**7: EXTENSION CORDS USED AS PERMANENT WIRING**

Extension cords were observed being used as permanent wiring. The National Electrical Code (NEC) does not allow extension cords in lieu of permanent wiring. If equipment is powered from an extension cord for more than 30 days, permanent solutions should be installed.

Recommendation: Contact a qualified electrical contractor.

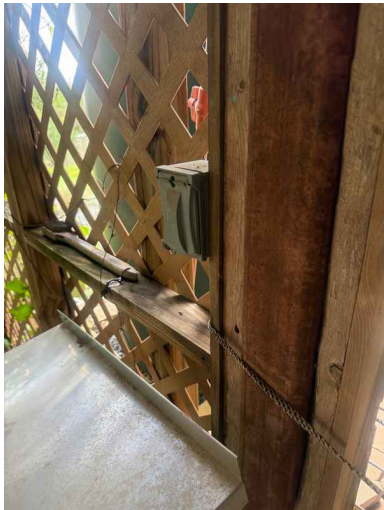
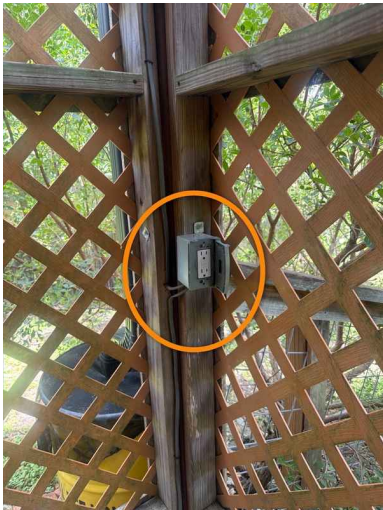
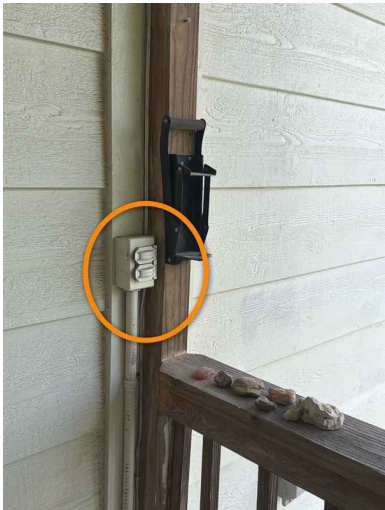
Back Of Home

**8: EXTERIOR RECEPTACLE(S) MISSING BUBBLE COVER**

Exterior electrical receptacles in locations that are not covered by a porch covering/roof should have weather tight bubble covers. One or more receptacles in such locations were missing proper bubble cover.

Recommendation: Contact a qualified electrical contractor.

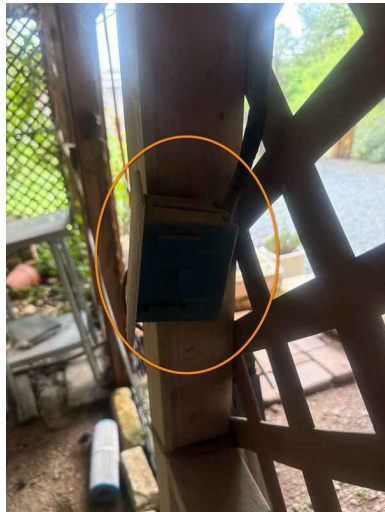
**9: IMPROPER WIRE IN WET LOCATION**

There were conductors that are not rated for wet locations installed in a wet location. Modern building standards consider raceways and conduit in the exterior to be wet locations. Only cables approved for wet locations should be run through exterior conduit. We recommend further evaluation and repair as necessary by a licensed electrical contractor.

Non-weathertight junction box used at exterior, Back Of Home

Recommendation: Contact a qualified electrical contractor.

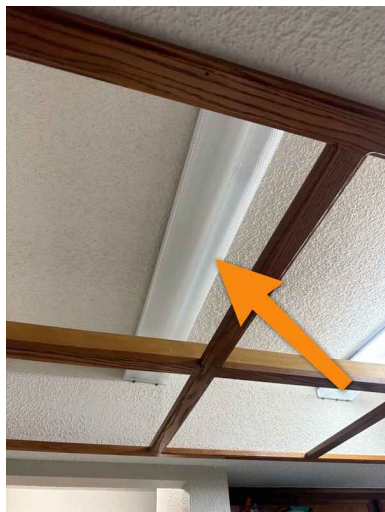
Kitchen

**10: LIGHT INOPERABLE**

The light in the referenced area(s) did not operate as intended. It could be due to a burned out bulb or an electrical issue. We recommend further evaluation by a licensed electrician prior to closing.

Recommendation: Contact a qualified electrical contractor.

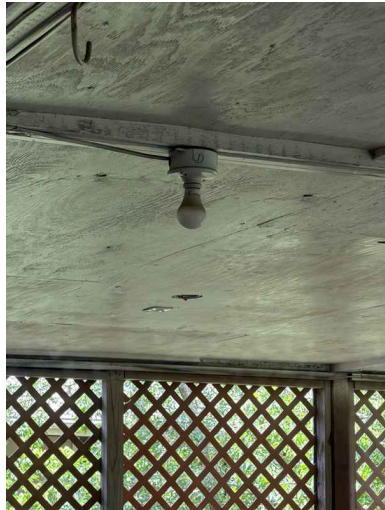
Back Of Home

**11: LIGHT COVER MISSING/DAMAGED**

One or more lights had a missing/damaged protective cover. We recommend adding a cover to protect the bulb and to minimize accidentally coming in direct contact with bulbs.

Recommendation: Contact a handyman or DIY project

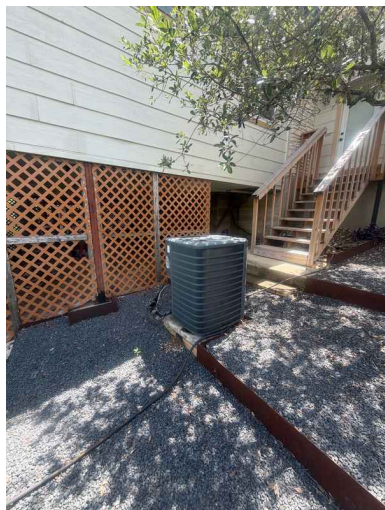
HVAC exterior condenser

**12: RECEPTACLES NOT PRESENT WHERE CURRENTLY REQUIRED**

Receptacles were observed to not be present at currently required areas. This home may pre-date this standard.

Recommendation: Contact a qualified electrical contractor.

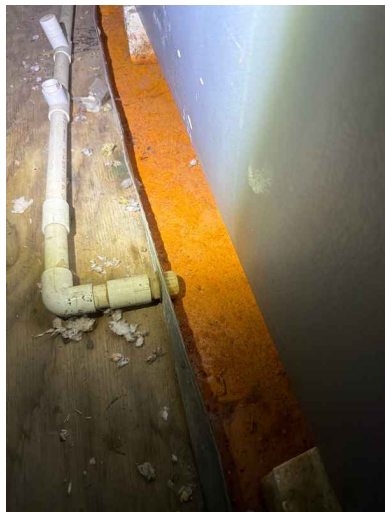
#### 7: PRIMARY CONDENSATE DRAIN - NOT INSULATED

The portion of the primary condensate drain pipe that is exposed is not insulated. It is recommended that the pipe be insulated to prevent sweating and dripping into the attic.

Recommendation: Contact a handyman or DIY project

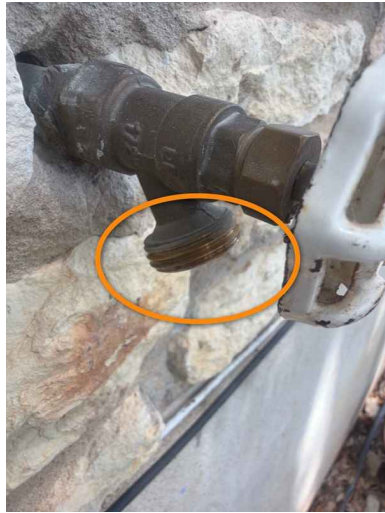
Front Of Home

**1: EXTERIOR FAUCET - MISSING ANTI - SIPHON**

One or more exterior hose bibs was not equipped with anti siphon device. These are designed to help prevent back siphon-age should something happen on the city side that causes a pressure drop. Recommend adding anti-siphon device by a licensed plumbing professional.

Recommendation: Contact a qualified plumbing contractor.

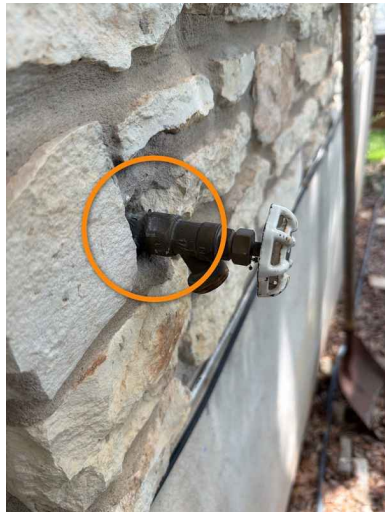
Front Of Home

## 2: EXTERIOR FAUCET - MISSING FROST PROTECTION

The exterior hose bib was not insulated or otherwise protected from freeze/thaw cycles. Recommend insulation to prevent bursting during times where temperatures reach freezing.

Recommendation: Contact a handyman or DIY project

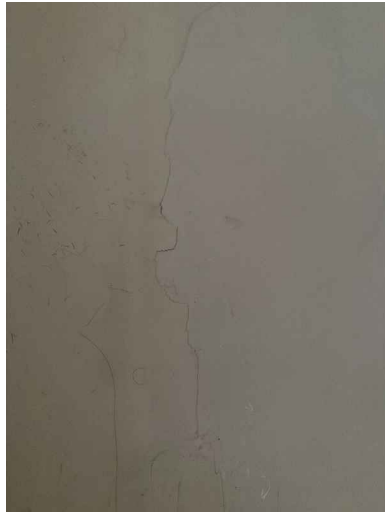
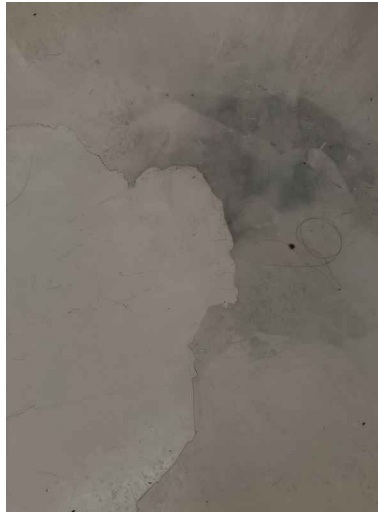
Hallway Bathroom

## 3: TUB / SHOWER / SINK- CRACKED / DAMAGED

Areas of the tub/shower/sink are cracked/damaged. In order to prevent moisture intrusion, I recommend having it evaluated and repaired/replaced as necessary by a licensed contractor.

Recommendation: Contact a qualified professional.

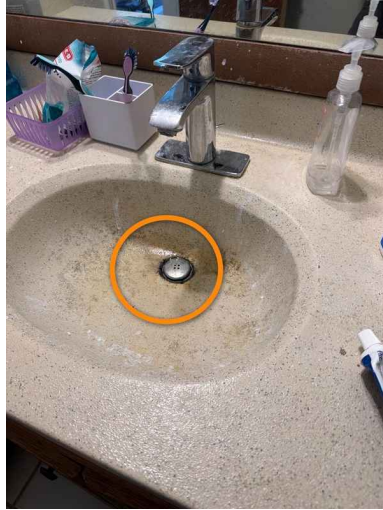
Hallway Bathroom

**1: DRAIN STOPPER(S) MISSING/FAULTY**

One or more drain stoppers was observed to either be missing or did not function properly to hold water in the sink/tub. We recommend repair for improved functionality.

Recommendation: Contact a qualified plumbing contractor.

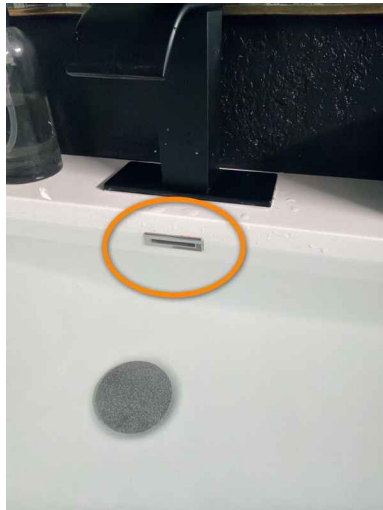
Primary Bathroom

One or more overflow drains do not drain adequately when engaged. May be clogged or have debris inside. Recommend repair/replacement.

Recommendation: Contact a qualified plumbing contractor.

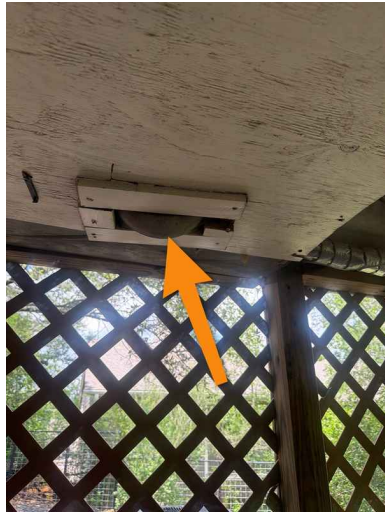
Under pier and beam elevated section

**3: P-TRAP NOT INSULATED IN EXTERIOR AREA**

A P-Trap was observed to not be insulated in an area exposed to weather. P-Traps hold water and could be susceptible to freezing/bursting if not properly insulated. We recommend insulation of P-Traps in areas outside of the building envelope.

Recommendation: Contact a qualified plumbing contractor.

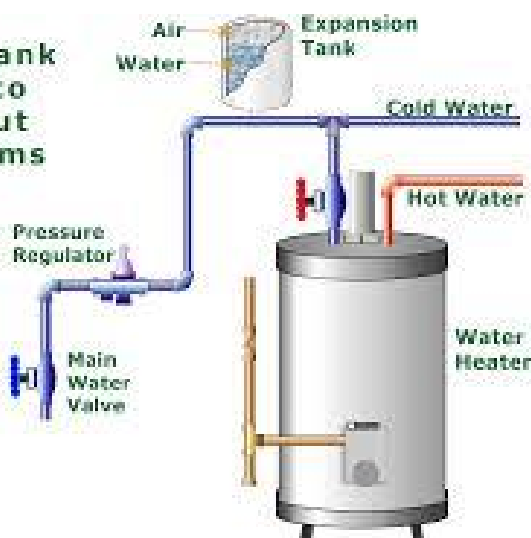
There is no expansion tank present on the unit. This is required when there is a pressure reducing valve at the water meter.

Recommendation: Contact a qualified professional.

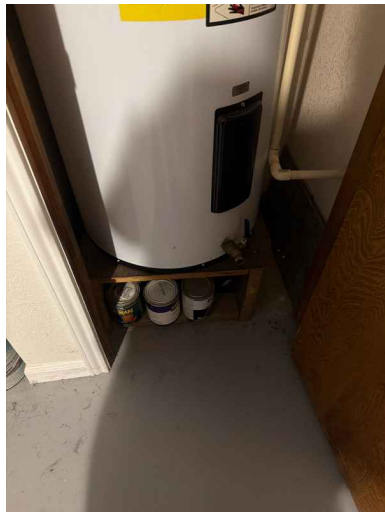
## 2: OVERFLOW PAN - NOT PRESENT

The water heating equipment was installed without an overflow pan. Current building standards state that all water heaters should be equipped with an overflow pan with a drain that drains to the exterior of the structure if leaks would cause damage.

Recommendation: Contact a qualified plumbing contractor.

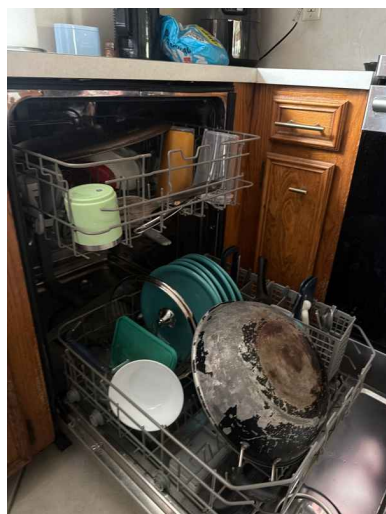
#### **DISHWASHER FULL OF DISHES:**

The dishwasher was full of dishes which prevented me from being able to fully inspect all areas of the racks for rust.

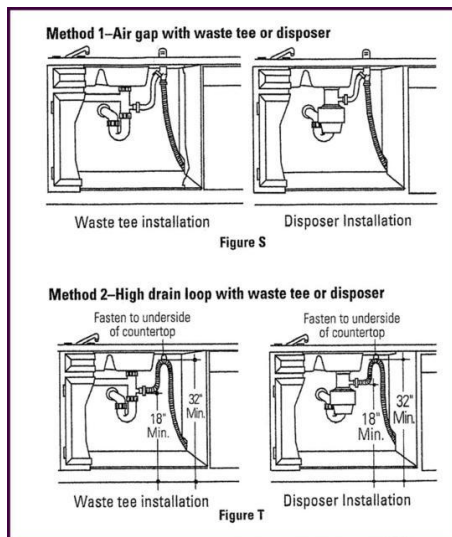
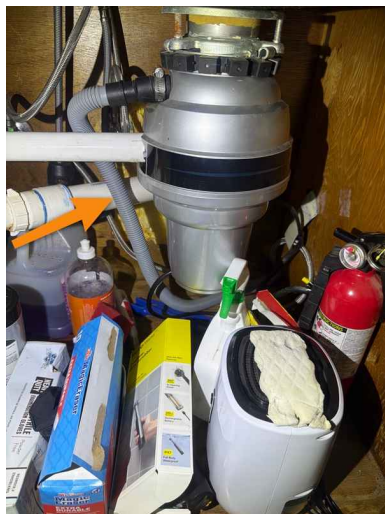
#### **1: NO HIGH LOOP**

Dishwasher did not have "high-loop" or air gap present. The purpose of a dishwasher air gap or high drain loop is to prevent back flow of water. The water can flow back into the dishwasher which will leave water in the bottom of the dishwasher. The high drain loop is also there to prevent improper drainage of water while the dishwasher is running. Image below shows the proper configurations of either an air gap or high loop.

Recommendation: Contact a handyman or DIY project

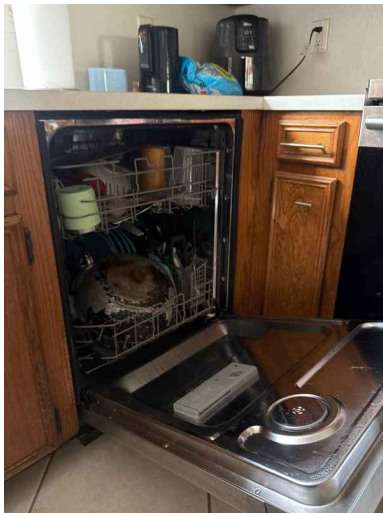
## 2: NOT MOUNTED SECURELY

The dishwasher was not anchored securely to the cabinet/counter where it was installed. We recommend securing it for safety and so it doesn't shake/rattle during operation.

Recommendation: Contact a handyman or DIY project

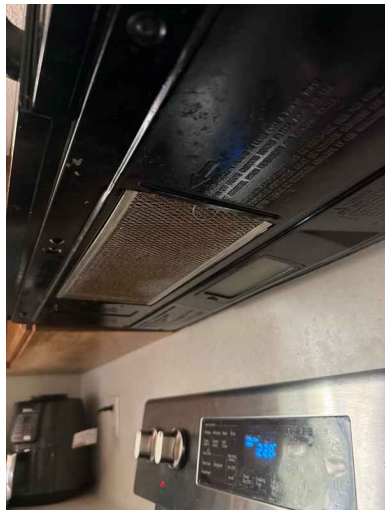
The light on the range hood did not work when engaged. We recommend replacement of the bulb. If this doesn't solve the problem, an appliance repair person may need to further evaluate.

Recommendation: Contact a handyman or DIY project

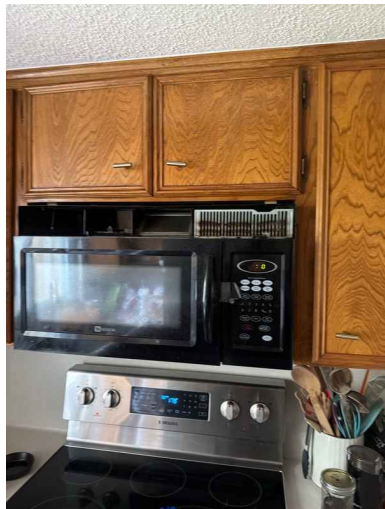
The microwave oven was inoperable at time of inspection. We recommend a qualified appliance repair person further evaluate and repair.

Recommendation: Contact a qualified appliance repair professional.

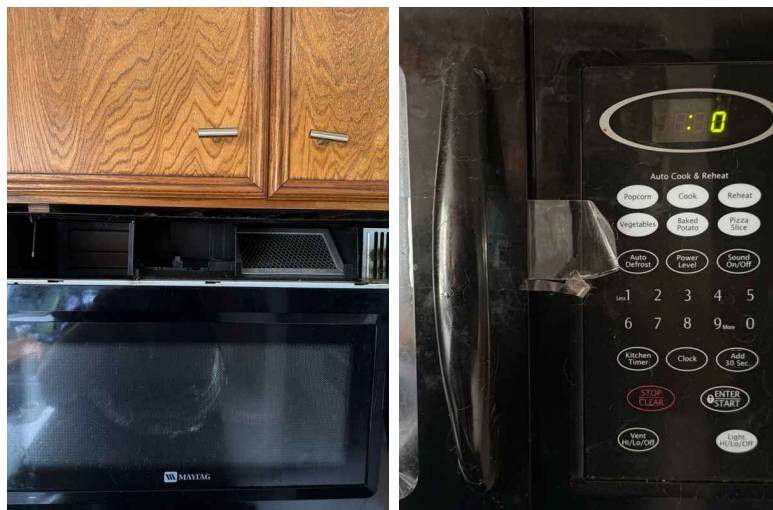
**2: PHYSICAL DAMAGE**

Physical damage was observed on the microwave however it appeared to be functioning properly. We recommend repair/replacement as needed.

Recommendation: Contact a qualified appliance repair professional.

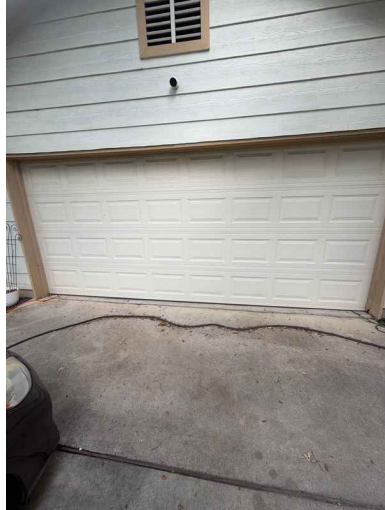
**1: PRESSURE REVERSE NOT WORKING PROPERLY****▲Safety Hazard/Significant Defect**

The pressure reverse feature was not properly responding at time of inspection. This is a safety hazard to children and pets. The door should reverse when physically obstructed to prevent crushing type injuries. We recommend a qualified garage door contractor evaluate and adjust the sensitivity of the tensioner.

Recommendation: Contact a qualified garage door contractor.
