## HOME CHECK IG RESIDENTIAL INSPECTION

6929 Chinook Dr  
Austin, TX 78736

# PROPERTY INSPECTION REPORT FORM

6929 Chinook Dr, Austin, TX 78736

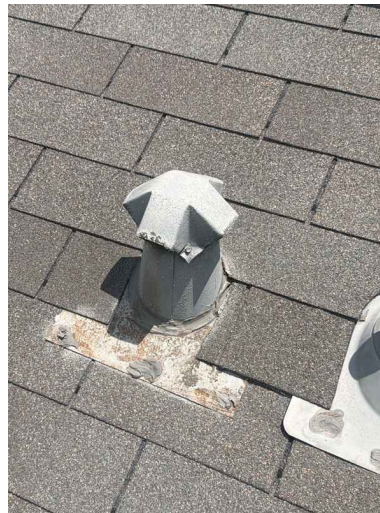
Whereas bathroom/attic vents can have a screen, dryer vents should have a damper. Using different vents could lead to lint build up inside which is dangerous and could cause fires. We recommend replacement of the vent as well as a duct cleaning as there may be lint buildup inside the ductwork currently due to the incorrect vent installation.

Recommendation: Contact a qualified roofing professional.

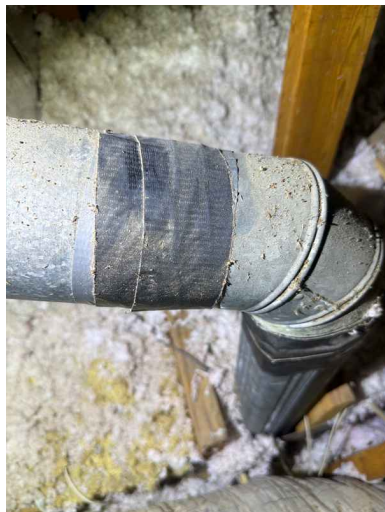
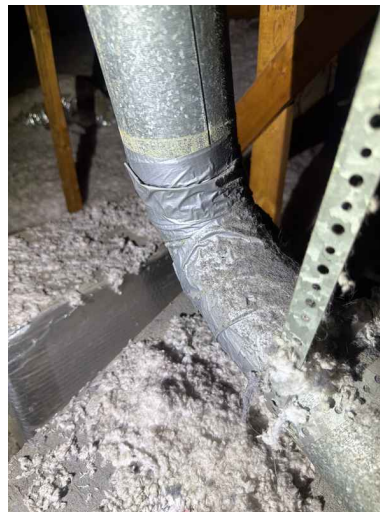
## 2: IMPROPER TAPE USED AT JOINTS

The dryer vent was not properly taped at the joints. Dryer vent joints should be sealed with metal tape that meets the requirements of the Underwriters Laboratory UL-181, UL-181A or 181B. Regular cloth-backed duct tape should not be used because it can dry out and fail quickly.

Recommendation: Contact a handyman or DIY project
